NUMBER: 08-003-21

Improved Steering Feel

2018 - 2020	(JL)	Jeep Wrangler
2020	(JT)	Jeep Gladiator

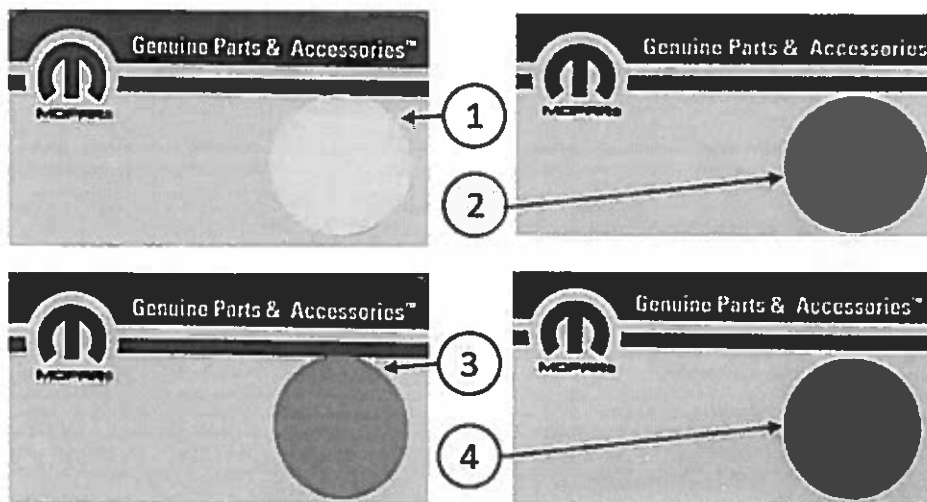
Fig. 1

The Steering Gear Parts Label Has A Color Dot On It To Help Confirm The Correct Steering Gear Was Ordered

- 1 - Yellow Dot, 68507576AA (JT Left Hand Drive (LHD))
- 2 - Red Dot, 68507569AA (JL 4 Door LHD, W/O EXJ 3.0 Diesel)
- 3 - Green Dot, 68507574AA (JL 4 Door LHD, With EXJ 3.0 Diesel)
- 4 - Blue Dot, 68507571AA (JL 2 Door LHD)
